# **Asbestos Survey Report**

**Block 93-109, Sandgate,  
Swindon  
13th December 2005**

This report contains the findings of a **Type 2 Survey** carried out at Block 93 – 109, Sandgate, Swindon.

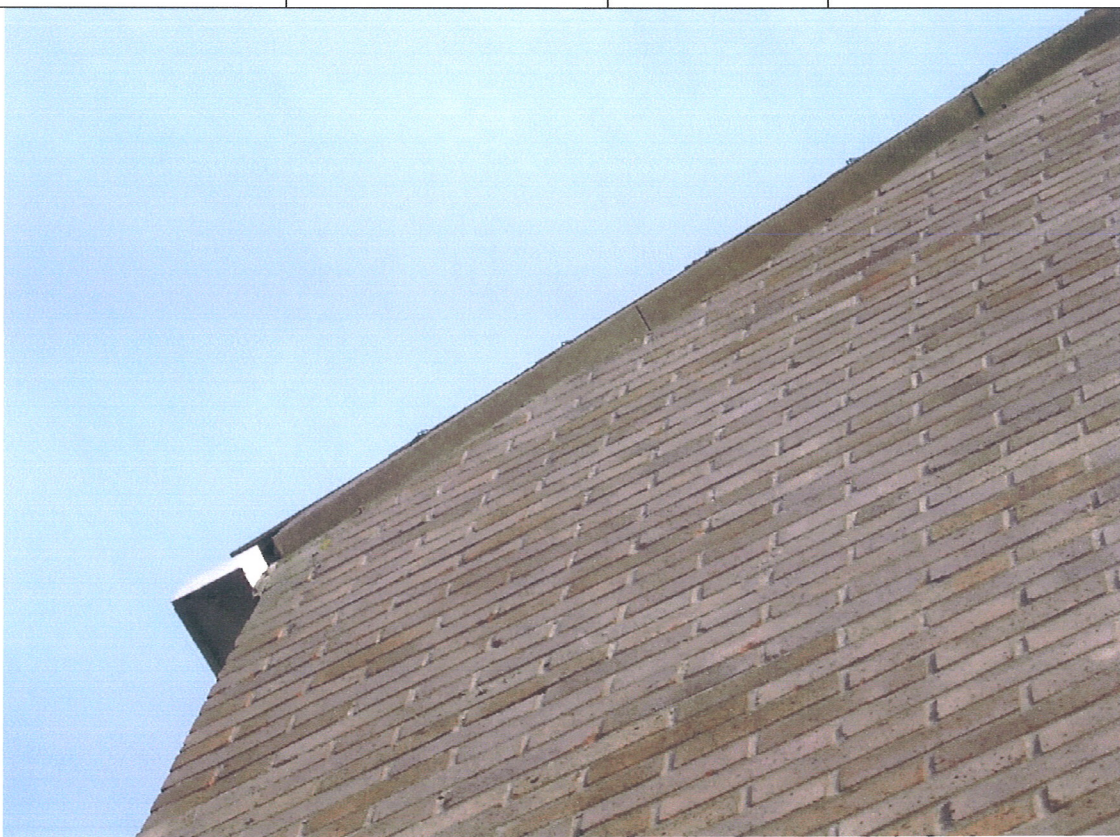
| Photo Ref: | A | Date taken | N/A |

| Location: | Exterior | | |
| Asbestos Type: | <b>Asbestos Containing Material – Presumed.</b> | | |
| Product/Use: | Eaves soffits | Amount | As seen |
| Accessibility: | Poor | | |

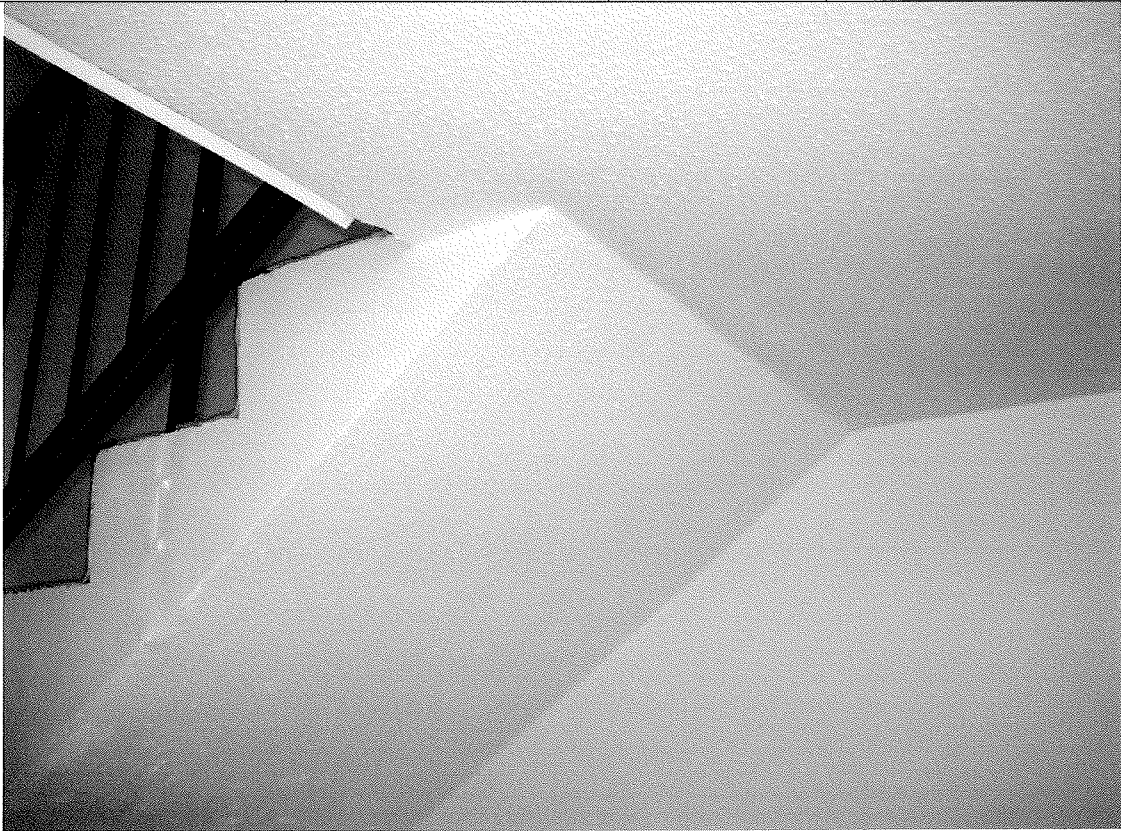
| Photo Ref: | B | Date taken | 13/12/05 |

| Location: | Entrance hallway | | |
| Asbestos Type: | <b>Chrysotile</b> | | |
| Product/Use: | Ceiling coating | Amount | As seen |
| Accessibility: | Good | | |

| TEST RESULTS | | | | |
|---|---|---|---|---|
| M068/131205/01 | 121450 | Entrance hallway | Ceiling coating | CHRYSTOTILE |

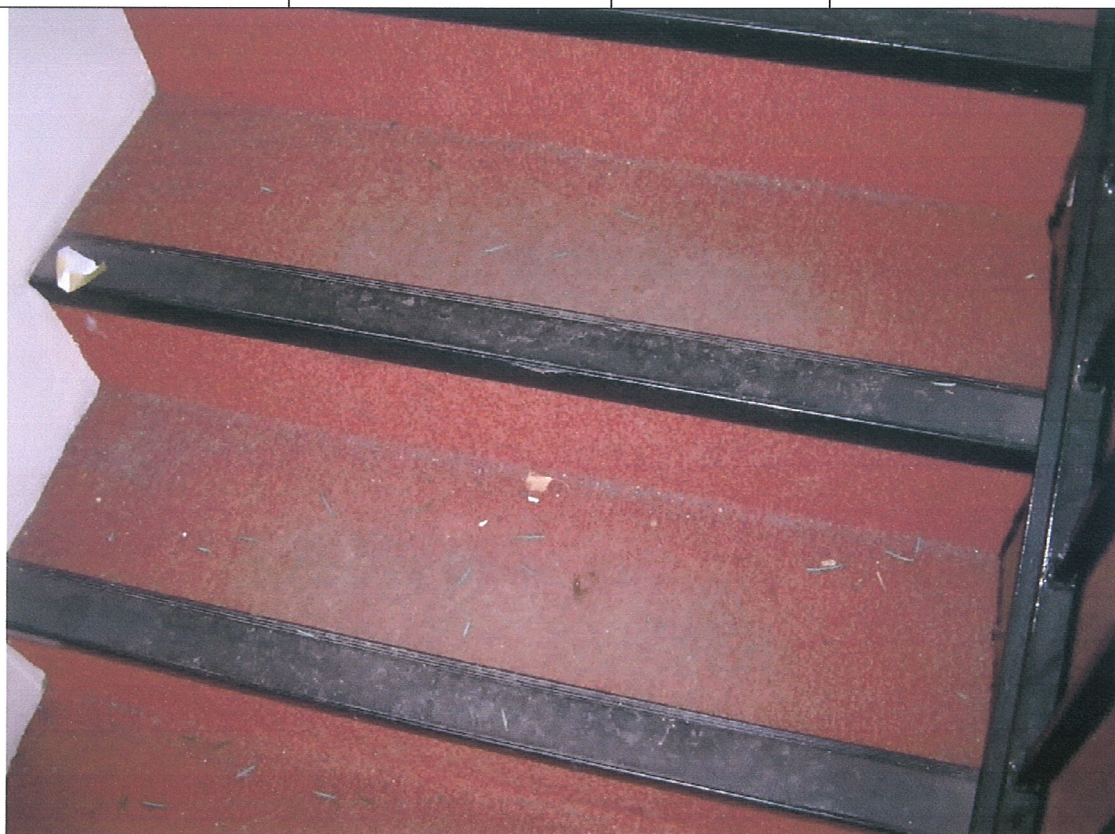
| Photo Ref: | C | Date taken | 13/12/05 |

| Location: | Stairs | | |

| Asbestos Type: | <b>No Asbestos Detected</b> | | |
| Product/Use: | Step return | Amount | As seen |
| Accessibility: | Good | | |

| TEST RESULTS | | | | |
|---|---|---|---|---|
| M068/131205/02 | 121451 | Stairs | Step return | NAD |
