COMBINED FIRE AND HEALTH & SAFETY RISK ASSESSMENT.

Address of premises:	93-109 Sandgate Stratton St Margaret Swindon SN3 4HJ
Responsible Person:	Sandgate RTM Company Ltd
Duty Holder:	Block Management Limited
Person(s) consulted:	No occupier or other relevant person available to consult.
Assessor:	Rob Cockburn
Report validated by:	John Godfrey, GIFireE.
Date of fire risk assessment:	26 th September 2024/ Reviewed September 2025
Date of previous fire risk assessment:	September 2022
Suggested date for review:	September 2026

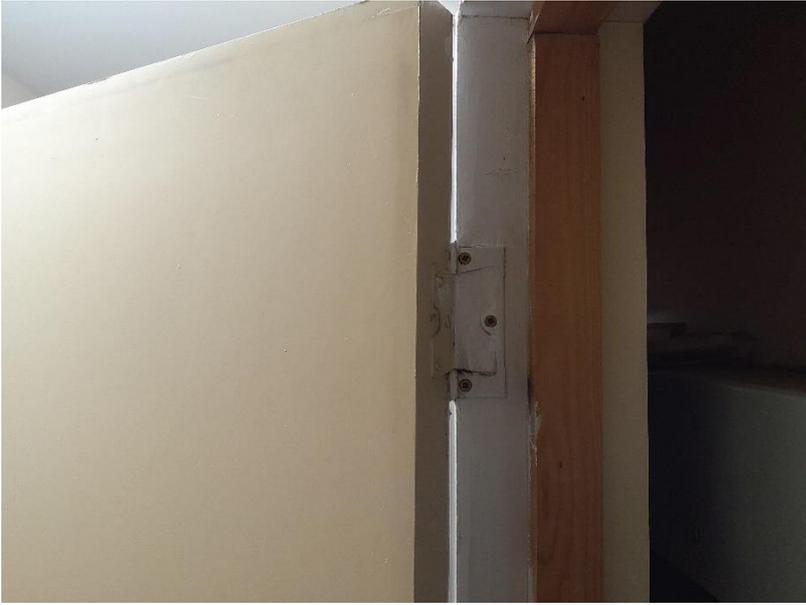
<p>04</p>	<p>It was noted during this fire risk assessment that the electrical intake cupboard doors, first floor lobby doors and second floor lobby doors were not suitable fire doors which could allow smoke and fire to spread into the means of escape. It is therefore recommended that the RP instructs a suitably qualified and competent contractor to upgrade the doors to FD30s Fire Doors providing a minimum of thirty minutes fire resistance and complete with a combined cold smoke and intumescent, hung on three grade 13 hinges and an appropriate FB lock.</p>

<p>2</p>	<p>B</p>	<p>Action required RP to consider replacement</p> <p>Lock installed to allow resident access to leaseholder apartment meters.</p>
-----------	--	----------	----------	---

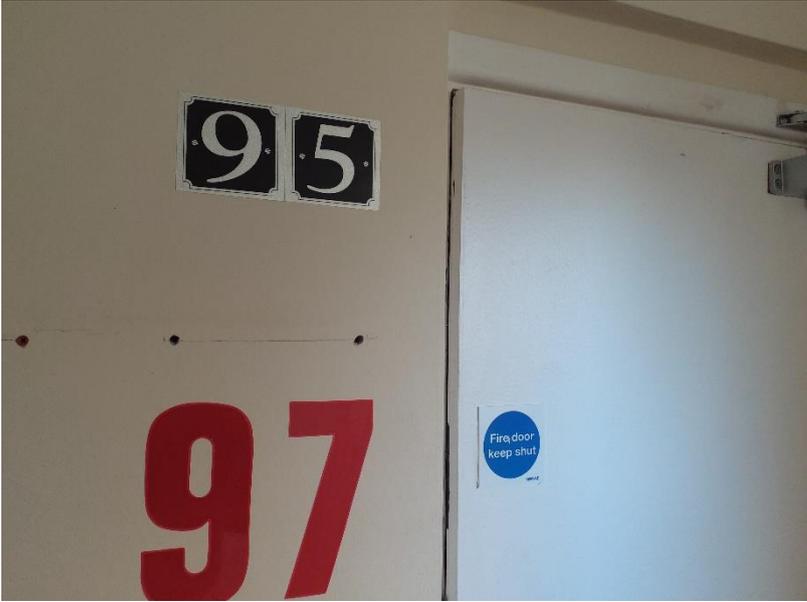
<p>05</p>	<p>It was noted during this fire risk assessment that the ground floor lobby door does not fully self-close which could allow smoke and fire to spread into the means of escape. It is therefore recommended that the RP instructs a suitably qualified and competent contractor to ease and adjust the closer in order to ensure the door fully self-closes as per Fire Safety (England) Regulations 2022 Fire Door Guidance Section 6.7H.</p>

<p>2</p>	<p>C</p>	<p>Action Complete</p>
<p>06</p>	<p>It was noted during this fire risk assessment that the ground floor lobby door had damaged smoke seals which could allow smoke to spread into the means of escape. It is therefore recommended that the RP instructs a suitably qualified and competent contractor to replace all damaged seals with a new combined cold smoke and intumescent seal as per Fire Safety (England) Regulations 2022 Fire Door Guidance Section 6.7F.</p>

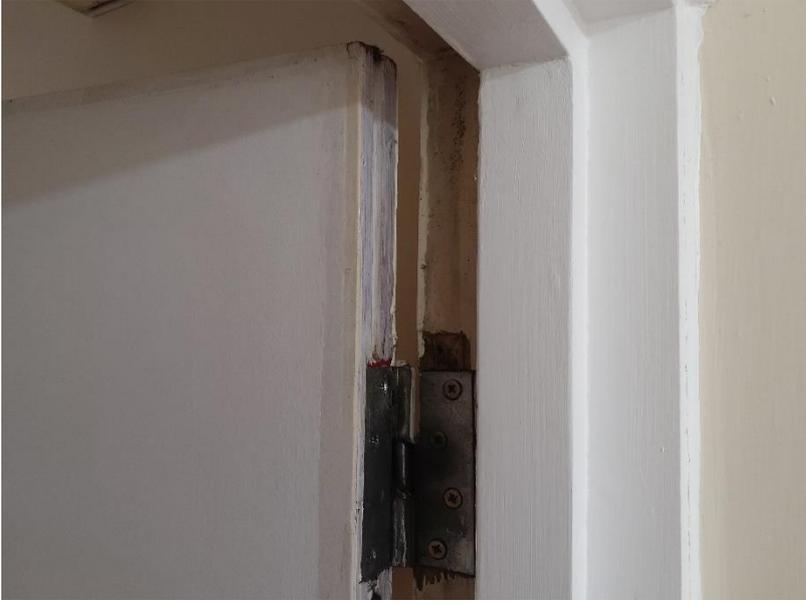
<p>07</p>	<p>As per section 33.2 of Fire Safety in Purpose-Built Block of Flats a type 1 fire risk assessment requires us to conduct a fire door survey on a sample of flat front doors. The door to Flat 101 was surveyed during this sample which appeared to be hung on three non-fire rated hinges along with no smoke seals.</p> <p>It is essential that each flat entrance door is a suitable fire door, providing a minimum of thirty minutes fire resistance, hung on three grade 13 hinges and having a functioning self-closing device fitted that positively closes the door on the latch, together with smoke and intumescent seals. It is recommended therefore that the RP instruct a suitably qualified and competent contractor to conduct a fire door inspection to all flat entrance doors and communal area doors providing advice on suitability. Any shortcomings identified by this inspection should be addressed as a priority by upgrading or replacing the door.</p> <p>Flat entrance doors, communal area doors, the seals and the self-closing devices should then be subjected to an annual inspection and maintenance schedule.</p>

<p>1</p>	<p>B</p>	<p>Action required DH provide safety notice to owners and via website.</p> <p>This report made available via website and on request.</p> <p>Last inspection June 2025</p>

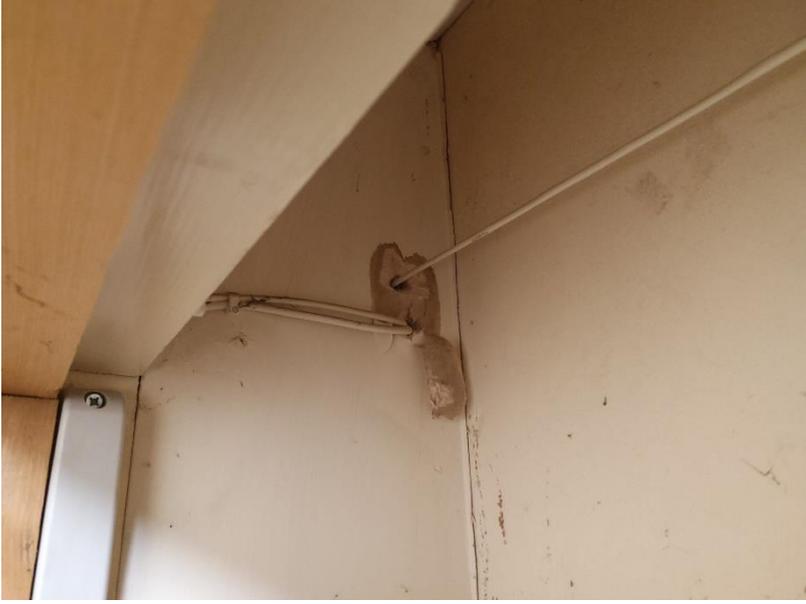
09	<p>It was noted during this fire risk assessment that there were small breaches within the electrical intake cupboard. It is recommended that the RP instructs a suitably qualified and competent contractor to repair all breaches with a suitable compound capable of providing a minimum of thirty minutes fire resistance in order to protect the means of escape from smoke and fire.</p>

2	C	Action required Contractor to make repairs
10	<p>It was noted during this fire risk assessment that hard wired smoke detectors were installed within the premises. This could be considered as an overprovision for this purpose-built block of flats implementing a stay put evacuation policy. Consideration could be given by the RP as to their removal. This is in line with current fire safety guidance for purpose-built flats.</p>	3	B	Action required RP to consider action
11	<p>Each flat is responsible for their own fire precautions and it is recommended that the RP advise each resident of the importance of installing smoke detectors within their flat. One battery operated smoke detector in the lobby of each flat would be the minimum provision, however mains powered smoke detectors, each with a battery backup, installed within the escape route of each flat, in all rooms that communicate with the escape route and a heat detector within the kitchen, interlinked to form a BS5839-6: 2019 Grade D detection system with LD2 coverage would be the preferred and safest option for each occupant.</p>	3	C	Ongoing action required DH provide safety notice and via website
